SPARKS ENGINEERING, INC.

February 29, 2008

SUBJECT: STRUCTURAL EVALUATION
Oakwood Cemetery Chapel
Austin, Texas

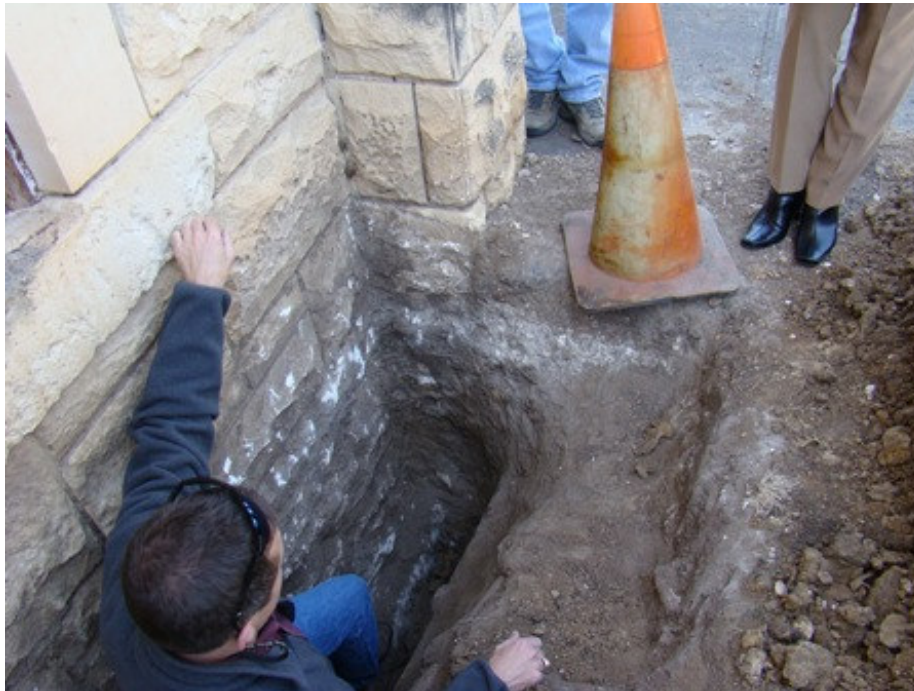
During our site visit, cemetery staff excavated one test pit to allow observation of the condition and depth of the foundation. The test pit was excavated on the east face of the building, to a depth of about 4-feet below grade. The foundation consists of shallow continuous concrete footings.

There are signs of past movement in the foundation, such as a diagonal crack on the north wall. Although this cracking does not present an immediate structural concern, there will likely be continued seasonal movement and recurrent cracking in the walls.

Foundation inspection pit.

1. Underpin the exterior walls with drilled piers. We expect that the piers will be at least 18-inches in diameter and 12-feet deep, depending on the bearing stratum.
2. Improve storm water control and surface drainage around the building:
 - a. Lower the grade as much as possible and slope the ground away from the building,
 - b. Install below-grade storm drains to collect the downspouts. Alternatively, assure that the downspouts discharge onto hard surfaces and that the water is conveyed away from the building. Replace the existing storm drains that do not function properly.
 - c. The sloped site may require the construction of a low retaining wall to manage the drainage

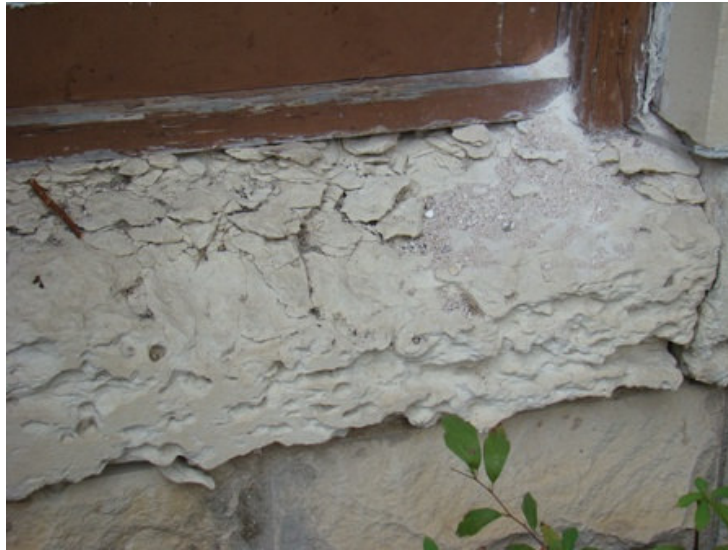
We assessed the ashlar limestone load-bearing walls for signs of distress. Cracks are present throughout the building, and are more visible on the interior due to the stucco finishing. An extended detachment of the stucco was also observed on interiors. Several sections of the stucco have collapsed and a poor connection between walls and remaining stucco was observed. On the exteriors, some stones are also detached and a significant degradation was observed mainly on the window sills and copings which are made of soft stone.

Degradation of window sills.

- d. Avoid high-water-demand landscape and large foundation plantings. Use drought-tolerant low ground cover near the building. Implement a reasonable irrigation program²,
3. Replace deteriorated sills and similar, more durable stone³.
4. Inject larger cracks with lime-based grout.
5. Selectively install retrofit veneer anchoring to assure the face stones are properly tied to the back up masonry (assume 25% of wall area).
6. Selectively repoint with lime mortar (match existing).
7. Repair, selectively replace, treat, and paint exterior and structural wood.
8. Replacement of detached interior stucco.

³ Chemical consolidation is an option on some sills and copings that are not yet significantly deteriorated.

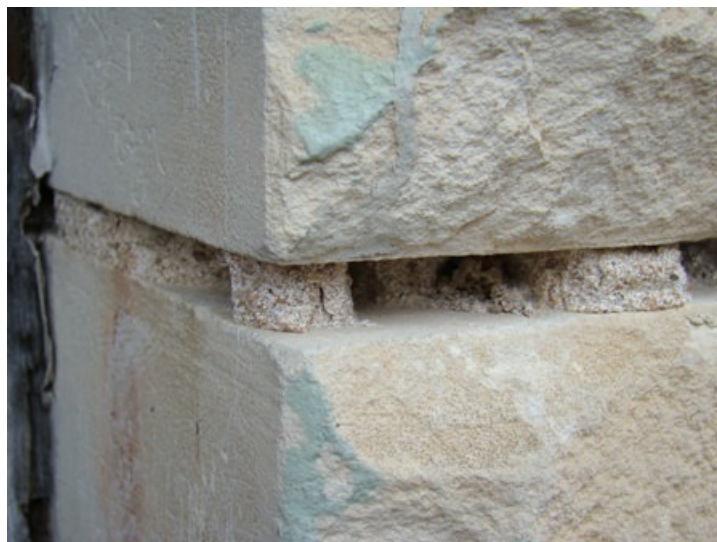
We observed a soft structural mortar in the wall joints. There is evidence of previous joint repointing campaigns in localized parts of the building. The newer repointing mortar is much harder and is portland cement based.

Erosion of original mortar joints due to rain.

The original mortar is made of irregular-shaped fragments of beige-colored sandy mortar material, as well as unconsolidated sand. The mortar is poorly cemented, and exhibited high friability. The binder

material appeared to be relatively homogeneous and is very soft. The binder material appears to be a calcitic lime paste. See full Mortar Analysis Report attached.

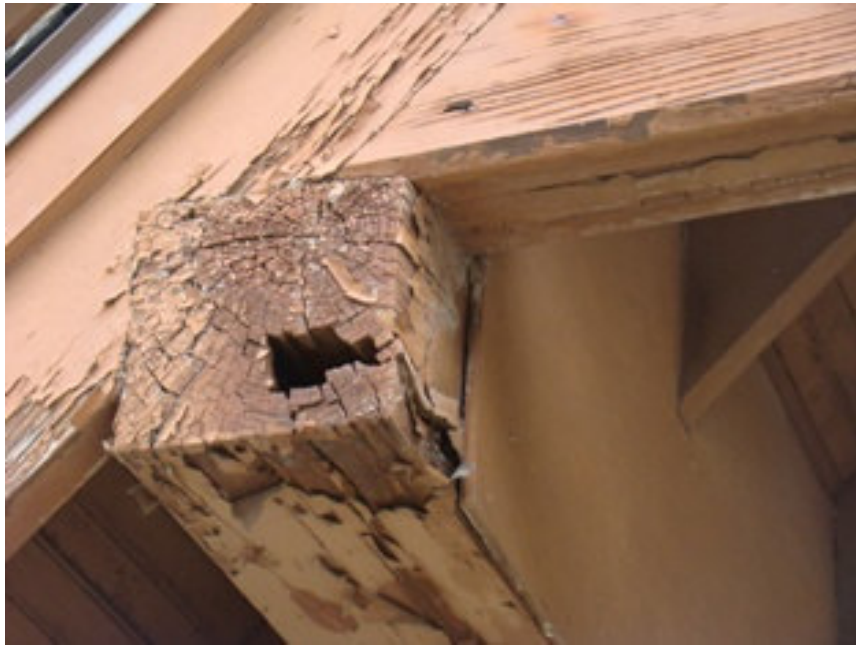
We assessed the visible sections of the wood roof and no major damage was observed. However, some decay is present on exterior sections of the roof, mainly where the wood is exposed to rain water. We also expect that some hidden decay exists which will be revealed when the roof is replaced.

Damage in exterior wooden roof due to rain water

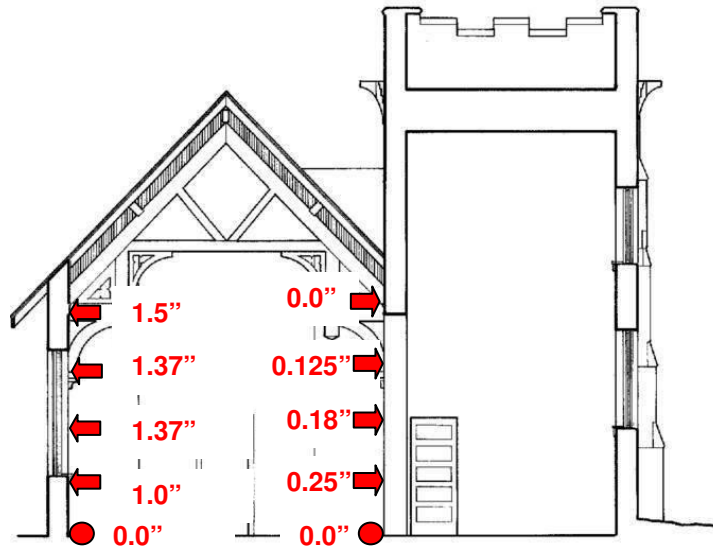
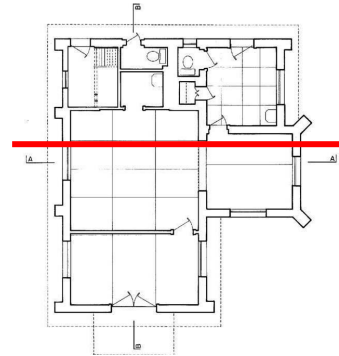
WALL DEFORMATION

We used a laser level to survey the lateral displacement of the east and west walls. A clear deformation was observed on the west wall. The results of the survey are attached to this report.

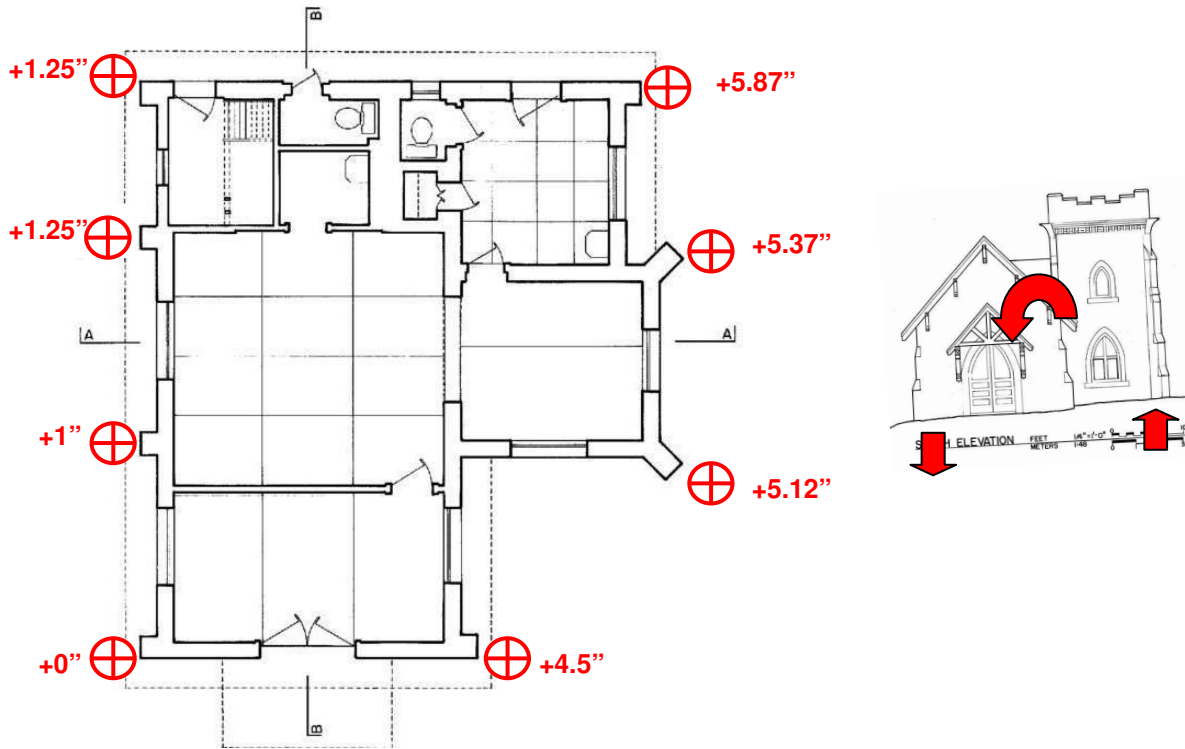
ELEVATION SURVEY

In addition, we developed a settlement survey on the exterior using as a reference the coping stone on the buttresses on each buttress of the building. A clear relative settlement between east and west walls was observed, in some cases exceeding five inches. For detailed information, please refer to the elevation report attached.

Differences in level for low coping stones in buttresses (left). Settling trend of the Chapel (right)

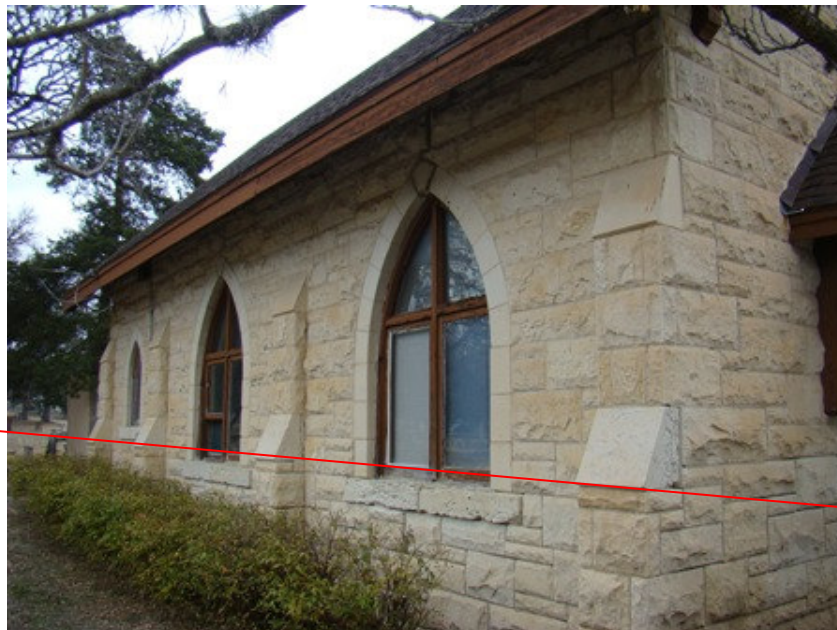
Coping stones in buttresses used as a horizontal Baseline for level comparison
